Centerville Playground

Town of Barnstable
ADA Transition Plan

August 2021

**Town of Barnstable
Centerville Playground**

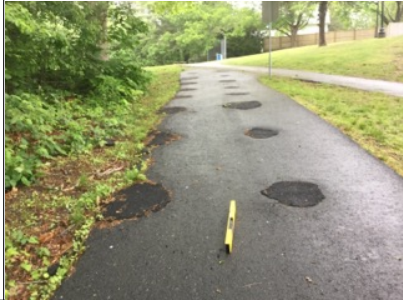
Cross slope > 1:50 (2.00%) Running slope > 1:20 (5%)	5.2% 8.8%	Reduce cross slope to be no steeper than 1:50 (2.00%). Reduce running slope to be no steeper than 1:20 (5%).	1	-	\$0
2	Route From West Parking Lot at Centerville Recreation Building	Ext.		Exterior Access Route	Walkway

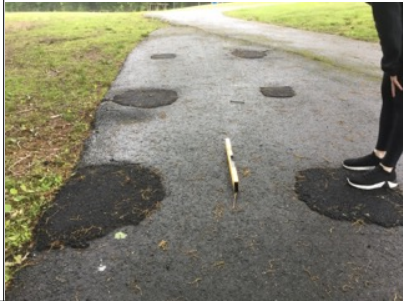
Cross slope > 1:50 (2.00%) Running slope > 1:20 (5%)	4% 9.6%	Reduce cross slope to be no steeper than 1:50 (2.00%). Reduce running slope to be no steeper than 1:20 (5%).	1	-	\$0
3	Pedestrian Access From Main Street Sidewalk to Playground	Ext.		Exterior Access Route	Walkway

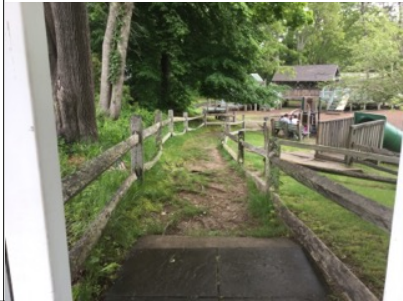
Cross slope > 1:50 (2.00%) Running slope > 1:20 (5%) Level changes > 1/4" Surface is not stable, firm, and slip-resistant Does not prevent accumulation of water Route not maintained in operable working condition Accessible route not provided	19.5% 9% 5" - - -	Reduce cross slope to be no steeper than 1:50 (2.00%). Reduce running slope to be no steeper than 1:20 (5%). Alter change in level to be 1/4" high max. Repair surface. Ensure the accessible route is maintained in operable working condition. Ensure an accessible route is provided.	1	-	\$0

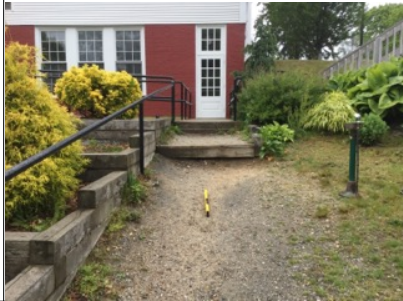
4	Ramp Route to the Playground From West Side Parking Lot	Ext.		Exterior Access Route	Walkway

Cross slope > 1:50 (2.00%) Running slope > 1:20 (5%) Surface is not stable, firm, and slip-resistant	5.9% 15.9% -	Reduce cross slope to be no steeper than 1:50 (2.00%). Reduce running slope to be no steeper than 1:20 (5%). Repair surface.	1	-	\$0
5	Route From West Parking Lot at Centerville Recreation Building	Ext.		Exterior Access Route	Walkway

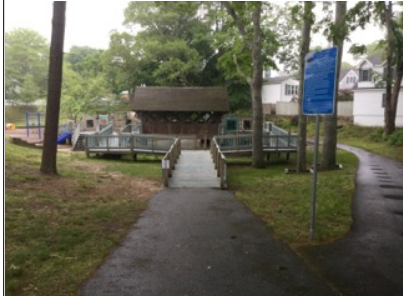
Running slope > 1:20 (5%)	8.9%	Reduce running slope to be no steeper than 1:20 (5%).	1	-	\$0

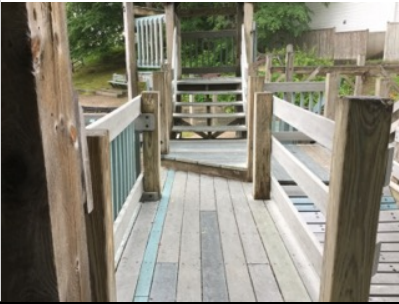
Level changes > 1/4"	5.75"	Alter change in level to be 1/4" high max.	1	-	\$0
12	Inside Playground	Ext.		Exterior Access Route	Walkway

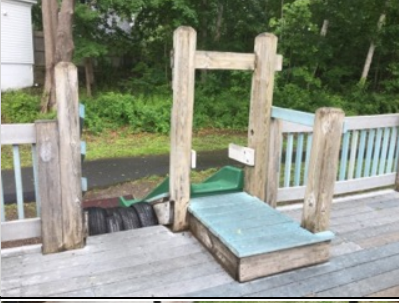
Level changes > 1/4"	9.5"	Alter change in level to be 1/4" high max.	1	-	\$0
13	Front Parking Lot Entrance to Playground			Exterior Access Route	Walkway

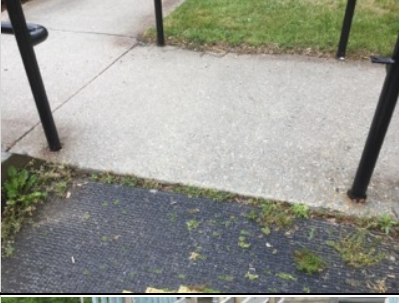
Level changes > 1/4"	1.75"	Alter change in level to be 1/4" high max.	1	-	\$0
14	Inside Playground	Ext.		Exterior Access Route	Walkway

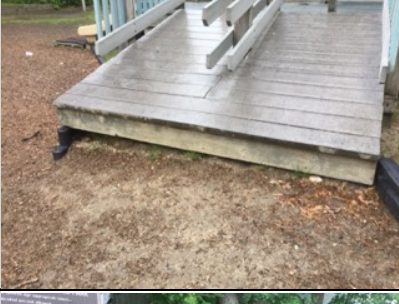
Level changes > 1/4" Surface is not stable, firm, and slip-resistant	12" -	Alter change in level to be 1/4" high max. Repair surface. Ensure a stable, firm and slip resistant accessible route is provided to the playground.	1	-	\$0
15	Pedestrian Access From Main Street Sidewalk to Playground	Ext.		Exterior Access Route	Exterior

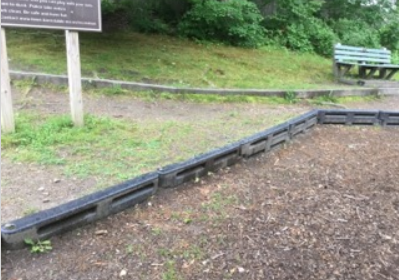
Level changes > 1/4" Surface is not stable, firm, and slip-resistant Accessible route not provided	10" - -	Alter change in level to be 1/4" high max. Ensure a stable, firm and slip resistant accessible route is provided to the playground.	1	-	\$0

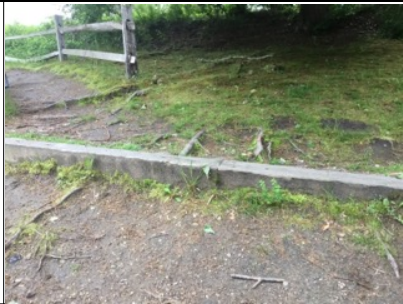
Level changes > 1/4" Accessible route not provided	10" -	Alter change in level to be 1/4" high max. Ensure an accessible route is provided.	1	-	\$0
17	Inside Playground	Ext.		Exterior Access Route	Walkway

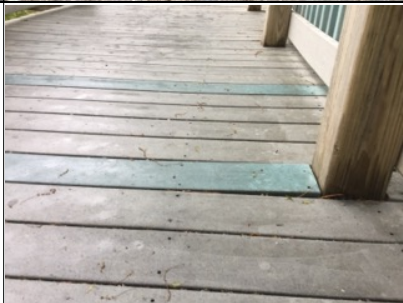
Surface is not stable, firm, and slip-resistant	-	Repair surface.	1	-	\$0
18	Inside Playground	Ext.		Exterior Access Route	Exterior

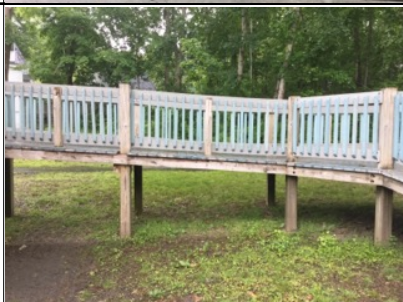
Surface is not stable, firm, and slip-resistant Vertical clearance < 80" above ground	- 31"	Repair surface. Provide a cane-detectable barrier underneath stair that is 27" max. above the ground.	1	-	\$0
19	Ramp Route to the Playground From West Side Parking Lot	Ext.		Exterior Access Route	Exterior

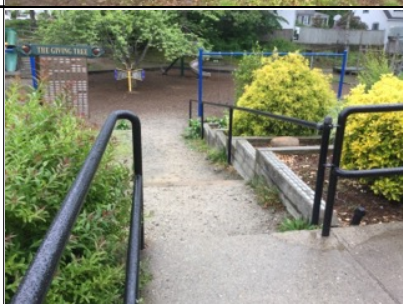
Accessible route not provided	-	Ensure an accessible route is provided.	1	-	\$0

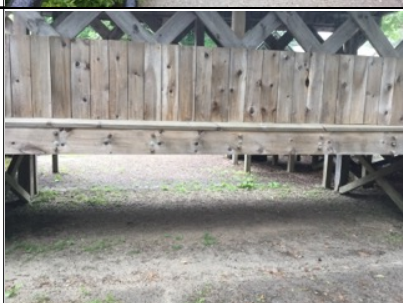
20	Inside Playground	Ext.		Exterior Access Route	Exterior

Vertical clearance < 80" above ground	45"	Provide a cane-detectable barrier underneath stair that is 27" max. above the ground.	1	-	\$0

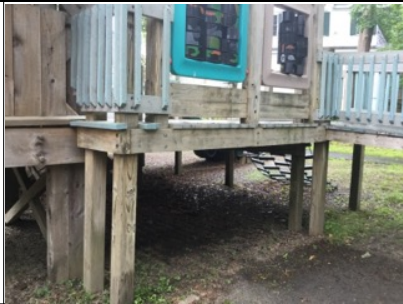
Vertical clearance < 80" above ground	48"	Provide a cane-detectable barrier underneath stair that is 27" max. above the ground.	1	-	\$0
Access to Goods and Services												
Ramps												
22	Ramp Route to the Playground From West Side Parking Lot	Ext.		Ramps	Exterior

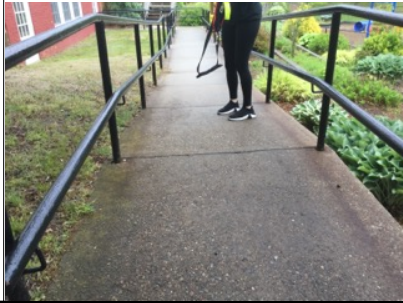
Running slope >1:12 (8.33%)	12.4%	Reduce running slope to be no steeper than 1:12 (8.33%).	1	-	\$0
23	Inside Playground	Ext.		Ramps	Exterior

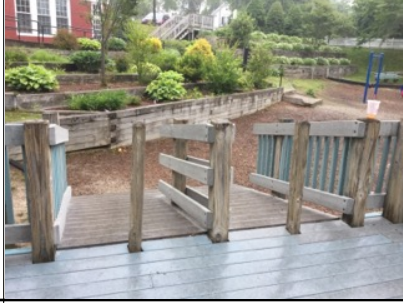
Running slope >1:12 (8.33%) Handrails do not extend 12" past top & bottom Handrails have non-compliant cross section	24.3% - -	Reduce running slope to be no steeper than 1:12 (8.33%). Alter handrails to extend horizontally above the landing for 12" min. beyond the top and bottom of ramp runs. Provide handrails with 1-1/4" to 1-1/2" circular cross section.	1	-	\$0

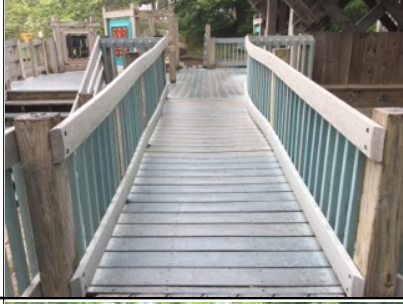
24	Inside Playground	Ext.	Top	Ramps	Exterior

Running slope >1:12 (8.33%) Handrails have non-compliant cross section	9.4% -	Reduce running slope to be no steeper than 1:12 (8.33%). Provide handrails with 1-1/4" to 1-1/2" circular cross section.	1	-	\$0
25	Ramp Route to the Playground From West Side Parking Lot	Ext.		Ramps	Exterior

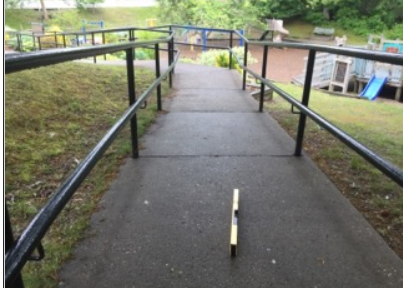
Running slope >1:12 (8.33%) Edge protection < 4" high	9.2% -	Reduce running slope to be no steeper than 1:12 (8.33%). Provide edge protection that prevents the passage of a 4" diameter sphere, where any portion of the sphere is within 4" of the finished floor or ground surface.	1	-	\$0

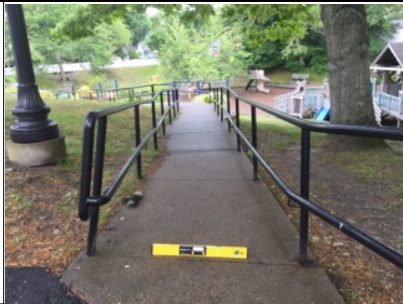
Cross slope > 1:50 (2.00%) (MAAB)	11.1%	Reduce the cross slope to be no steeper than 1:50 (2.00%).	1	-	\$0
27	Ramp Route to the Playground From West Side Parking Lot	Ext.		Ramps	Exterior

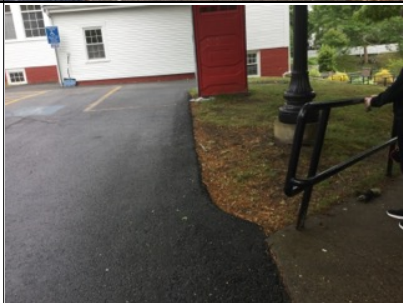
Handrails do not extend 12" past top & bottom	-	Alter handrails to extend horizontally above the landing for 12" min. beyond the top and bottom of ramp runs.	1	-	\$0
28	Inside Playground	Ext.		Ramps	Exterior

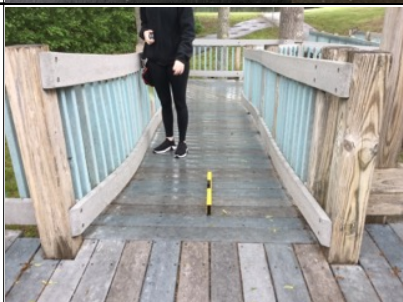
Handrails do not extend 12" past top & bottom Handrails have non-compliant cross section Surface not stable, firm, and slip-resistant	- - -	Alter handrails to extend horizontally above the landing for 12" min. beyond the top and bottom of ramp runs. Provide handrails with 1-1/4" to 1-1/2" circular cross section. Repair surface.	1	-	\$0

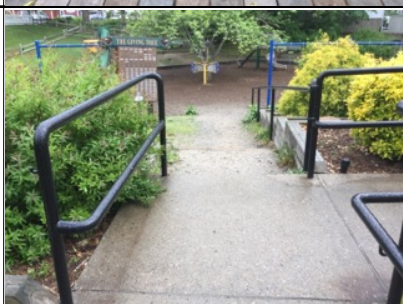
29	Ramp Route to the Playground From West Side Parking Lot	Ext.		Ramps	Exterior

Edge protection < 4" high	-	Provide edge protection that prevents the passage of a 4" diameter sphere, where any portion of the sphere is within 4" of the finished floor or ground surface.	1	-	\$0
Stairways												
30	East Parking Lot Entrance to Playground	Ext.		Stairways	Exterior

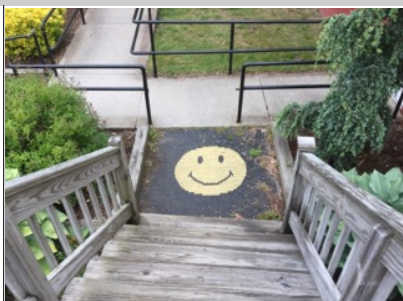
Handrail height < 34" or > 38"	45"	Alter so the handrails are 34"- 38" high above the floor.	1	-	\$0

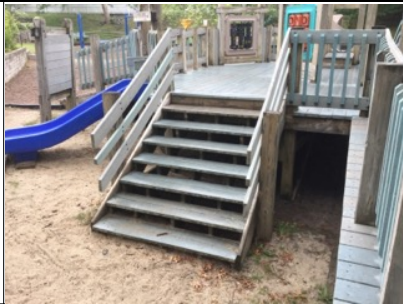
Handrail height < 34" or > 38" Handrails do not extend 12" from stairs Handrails have non-compliant cross section Tread widths and/or riser heights are not uniform Stair has open risers	32" - - -	Alter so the handrails are 34"- 38" high above the floor. Top: Ensure handrails extend horizontally above the landing for 12" min. beginning above the first riser nosing. Bottom: Ensure that the sloped bottom extension extends one tread depth minimum beyond last riser nosing in same direction as stair flight. Provide handrails with a 1 1/4" - 2" circular cross section. Ensure stairs have closed risers.	1	-	\$0
32	Inside Playground	Ext.		Stairways	Exterior

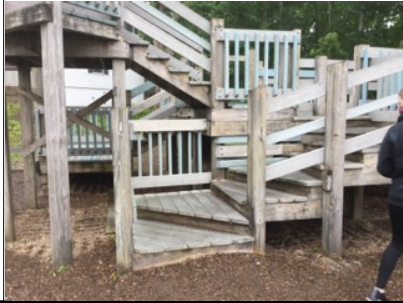
Handrail height < 34" or > 38" Handrails do not extend 12" from stairs Handrails have non-compliant cross section Risings > 7" high Tread widths and/or riser heights are not uniform	42" - 8" -	Repair to this stairway might be technically infeasible. Alter so the handrails are 34"- 38" high above the floor. Top: Ensure handrails extend horizontally above the landing for 12" min. beginning above the first riser nosing. Bottom: Ensure that the sloped bottom extension extends one tread depth min. beyond last riser nosing in same direction as stair. Provide handrails with a 1 1/4" - 2" circular cross section.	1x	-	\$0

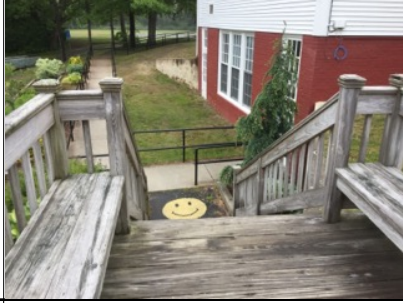
33	East Parking Lot Entrance to Playground			Stairways	Exterior

Handrails do not extend 12" from stairs Handrails have non-compliant cross section Risings > 7" high	- - 7.5"	Top: Ensure handrails extend horizontally above the landing for 12" min. beginning above the first riser nosing. Bottom: Ensure that the sloped bottom extension extends one tread depth minimum beyond last riser nosing in same direction as stair flight. Provide handrails with a 1 1/4" - 2" circular cross section. Repair to this stairway might be technically infeasible.	1	-	\$0
34	East Parking Lot Entrance to Playground			Stairways	Exterior

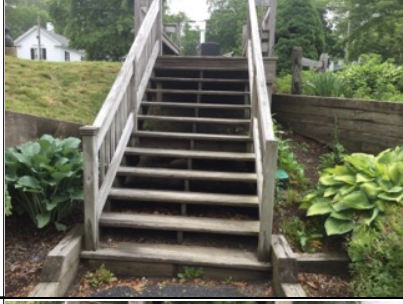
Handrails do not extend 12" from stairs Handrails have non-compliant cross section Tread widths and/or riser heights are not uniform	- - -	Top: Ensure handrails extend horizontally above the landing for 12" min. beginning above the first riser nosing. Bottom: Ensure that the sloped bottom extension extends one tread depth minimum beyond last riser nosing in same direction as stair flight. Provide handrails with a 1 1/4" - 2" circular cross section. It may not be technically feasible to adjust risers or treads, however stairs may be hazardous for users.	2	-	\$0

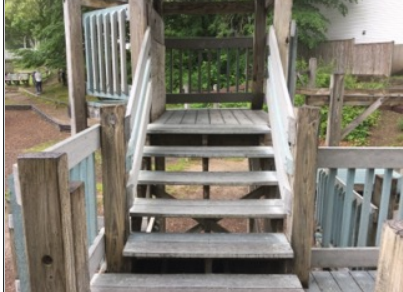
35	Inside Playground	Ext.		Stairways	Exterior

Handrails do not extend 12" from stairs Handrails have non-compliant cross section Stair has open risers	- - -	Top: Ensure handrails extend horizontally above the landing for 12" min. beginning above the first riser nosing. Bottom: Ensure that the sloped bottom extension extends one tread depth minimum beyond last riser nosing in same direction as stair flight. Provide handrails with a 1 1/4" - 2" circular cross section. Ensure all stairs in the playground have closed risers.	1	-	\$0

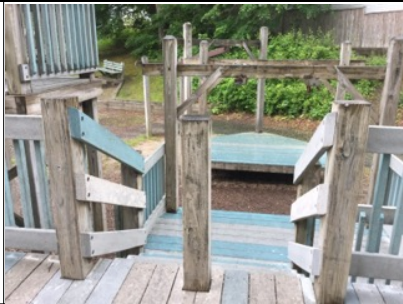
Handrails do not extend 12" from stairs Handrails have non-compliant cross section Stair has open risers	- - -	Top: Ensure handrails extend horizontally above the landing for 12" min. beginning above the first riser nosing. Bottom: Ensure that the sloped bottom extension extends one tread depth minimum beyond last riser nosing in same direction as stair flight. Provide handrails with a 1 1/4" - 2" circular cross section. Ensure stairs have closed risers.	1	-	\$0
37	Ramp Route to the Playground From West Side Parking Lot	Ext.		Stairways	Exterior

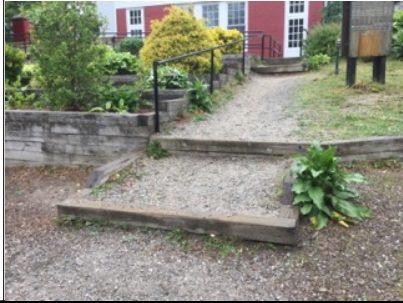
Handrails not continuous where required Risers > 7" high Surface not stable, firm, and slip-resistant Tread widths and/or riser heights are not uniform	- 8.75" - -	Provide continuous handrails. Repair surface.	1	-	\$0

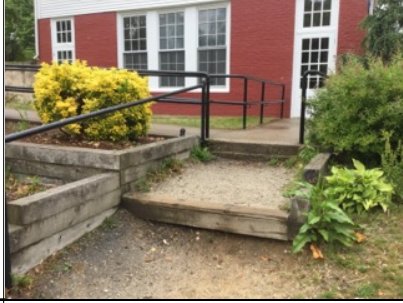
38	Ramp Route to the Playground From West Side Parking Lot	Ext.		Stairways	Exterior

Risers > 7" high Surface not stable, firm, and slip-resistant Handrails not provided Tread widths and/or riser heights are not uniform	14" - - -	Repair surface. Provide handrails.	1	-	\$0
39	Route From West Parking Lot at Centerville Recreation Building	Ext.		Stairways	Exterior

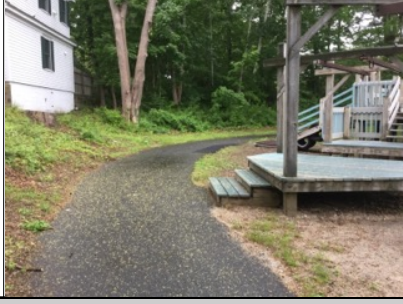
Risers > 7" high Handrails not provided Tread widths and/or riser heights are not uniform	7.5" - -	Provide handrails.	1	-	\$0
Signage												
40	East Parking Lot Entrance to Playground			Signage	Directional

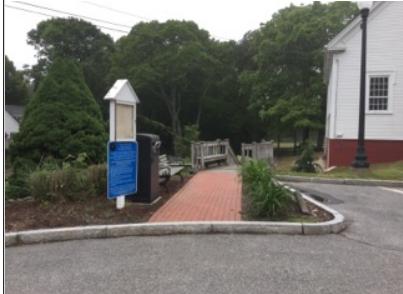
Directional sign to acc. entrance to playground not provided	-	Provide a sign indicating the location of the nearest accessible entrance to the playground.	1	-	\$0

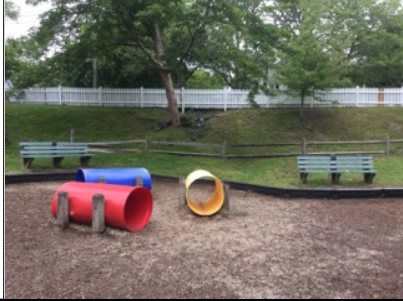
No accessible route to one bench in this area	-	Provide an accessible route to at least one bench in this area.	1	-	\$0
42	Pedestrian Access From Main Street Sidewalk to Playground	Ext.		Benches	N/A

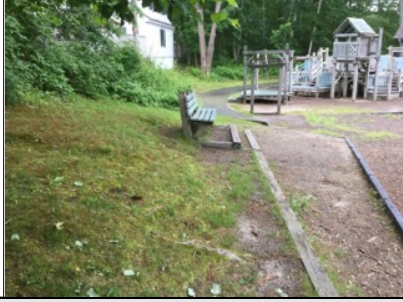
No accessible route to one bench in this area	-	Provide an accessible route to at least one bench in this area.	1	-	\$0
Toilet & Bathing Rooms												
Portable Toilet												
43	Portable Toilet by Rear Parking Lot			Portable Toilet	N/A

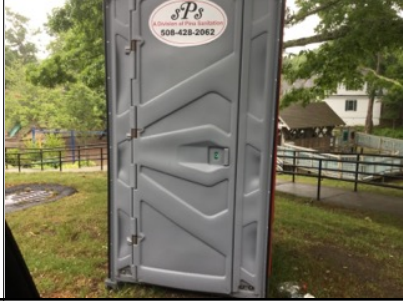
Not located on an accessible route Accessible portable toilets not provided	- -	Locate portable toilet on an accessible route. Ensure that at least 5% of portable toilets is accessible.	1	-	\$0
Additional Access												
Drinking Fountains												
44	Drinking Fountain	Ext.		Drinking Fountains	Seated

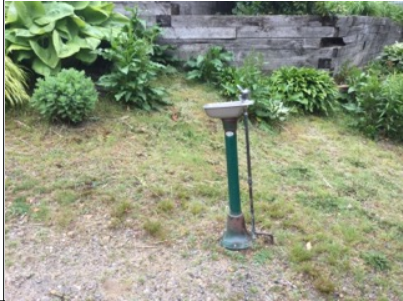
Fountain not on accessible route Spout < 38" or > 43" (standing users) No drinking fountain provided for seated users	- 31" -	Provide an accessible route to the drinking fountain. Relocate drinking fountain so that the spout is between 38"- 43" above the finished floor or ground. Provide an additional drinking fountain for seated users.	1	-	\$0

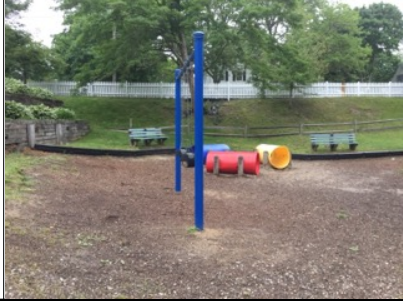
Accessible route not provided around playground Accessible route not provided at play components	- -	Install an accessible route to and around the playground. Provide a compliant impact-attenuating surface under and around the play components.	1	-	\$0
46	Playground	Ext.		Play Areas	N/A

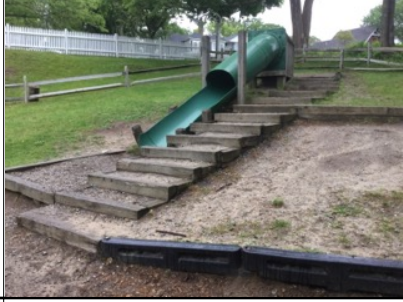
Accessible route not provided at play components	-	Provide a compliant impact-attenuating surface under and around the play components.	1	-	\$0
47	Playground			Play Areas	N/A

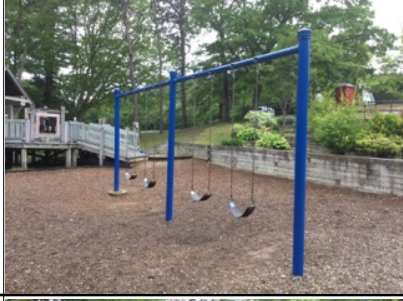
Accessible route not provided at play components	-	Provide a compliant impact-attenuating surface under and around the play components.	1	-	\$0
48	Playground			Play Areas	N/A

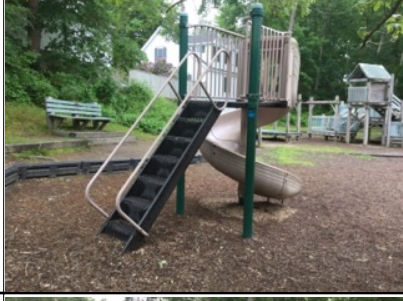
Accessible route not provided at play components	-	Provide a compliant impact-attenuating surface under and around the play components.	1	-	\$0

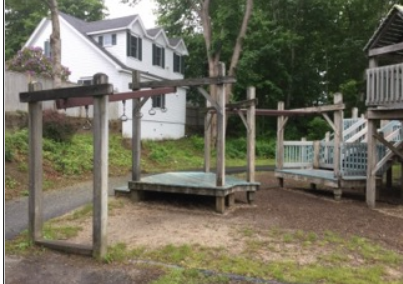
49	Playground			Play Areas	N/A

Accessible route not provided at play components	-	Provide a compliant impact-attenuating surface under and around the play components.	1	-	\$0

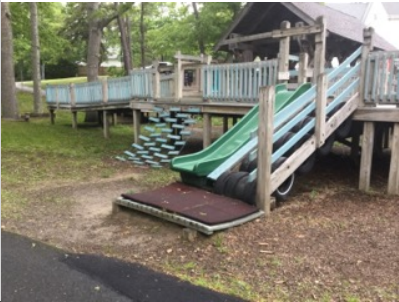
Accessible route not provided at play components	-	Provide a compliant impact-attenuating surface under and around the play components.	1	-	\$0
51	Playground			Play Areas	N/A

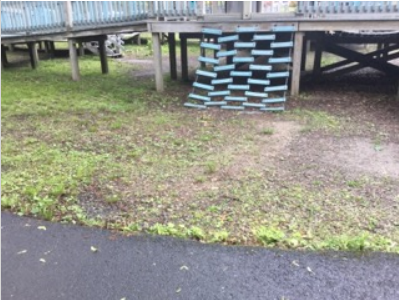
Accessible route not provided at play components	-	Provide a compliant impact-attenuating surface under and around the play components.	1	-	\$0
52	Playground			Play Areas	N/A

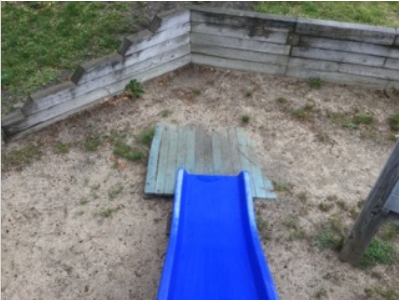
Accessible route not provided at play components	-	Provide a compliant impact-attenuating surface under and around the play components.	1	-	\$0
Best Practice												
53	Route From West Parking Lot at Centerville Recreation Building	Ext.			57
