# Hamblin Pond and Bathhouse

Town of Barnstable  
ADA Transition Plan

August 2021

**Town of Barnstable  
Hamblin Pond and Bathhouse**

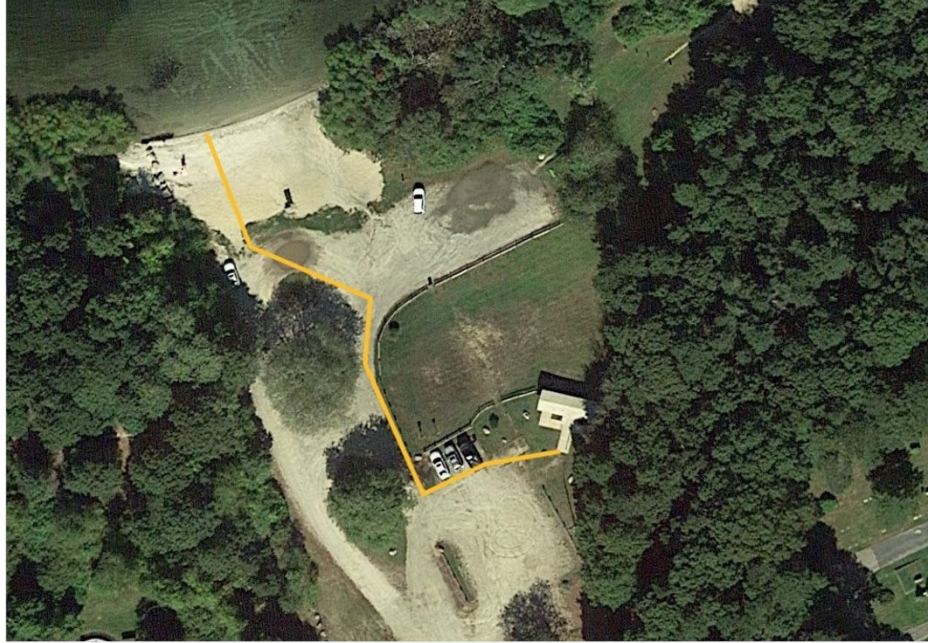
Possible accessible route

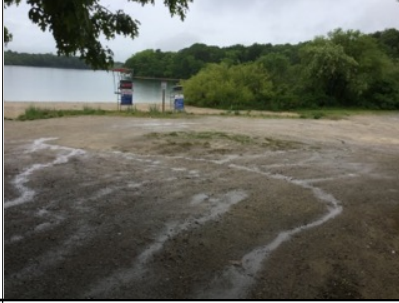
Surface is not stable, firm, and slip-resistant Does not prevent accumulation of water	- -	Repair surface.  See ID #2 for cost.	1	-	\$0
2	Bath House	Ext.		Exterior Access Route	Exterior

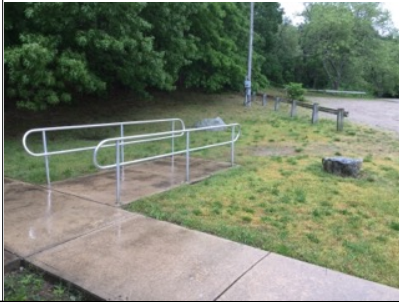
Surface is not stable, firm, and slip-resistant Accessible route not provided	- -	Extend the accessible route to the parking lot.	1	5792	\$5792
3	Route to Hamblin's Pond	Ext.		Exterior Access Route	Exterior

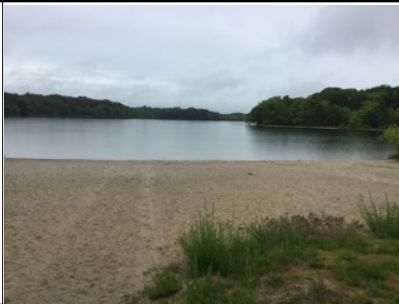
Beach route not provided	-	Provide an accessible route that is firm and stable. Ensure the accessible route extends to the recreation water level.  (Cost for a 6.5 ft. wide by 82 ft. long beach mat.)	1	3899	\$3899
<b>Off-Street Parking Lot or Garage</b>

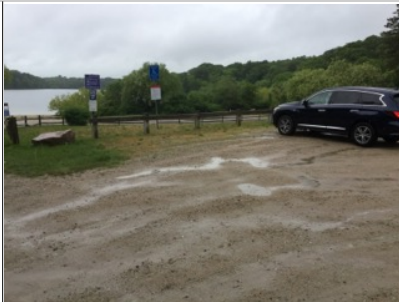
4	Parking Lot	Ext.		Off-Street Parking Lot or Garage	Visitor

Total # of designated van accessible spaces Surface not stable, firm, and slip-resistant	-	Provide a van accessible spaces that is at least 96" wide with a marked access aisle that is at least 96" wide. Ensure slope is not steeper than 1:50 (2.00%) in all directions. Add the designation "Van Accessible" to the sign. Repair surface. (See sketch for possible design of the parking space.)	1	1850	\$1850
<b>Access to Goods and Services</b>

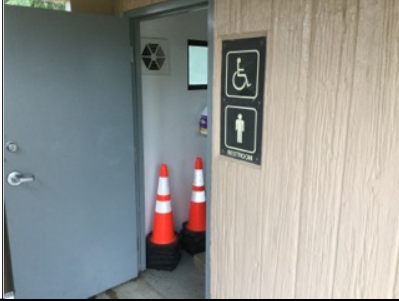
Raised characters not provided on sign	-	Provide text with raised characters duplicated in braille on sign.	1	232	\$232
6	Women's Toilet Room	1		Signage	Designation

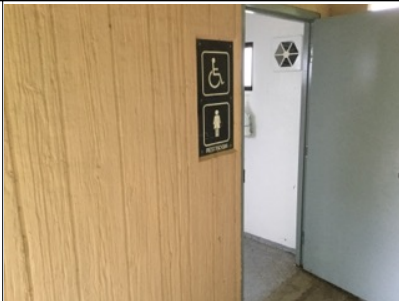
Raised characters not provided on sign	- -	Provide text with raised characters duplicated in braille on sign.	1	232	\$232
<b>Picnic Tables</b>												
7	Picnic Table Ref.	Ext.		Picnic Tables	N/A

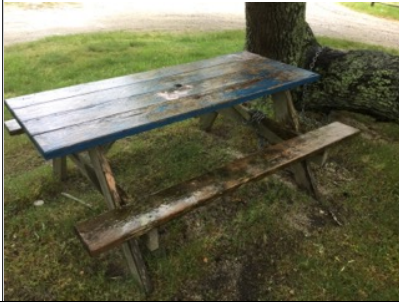
Toe or knee clearance at tables not provided	-	Provide a picnic table with knee and toe clearance.	1	1400	\$1400
8	Picnic Area	Ext.		Picnic Tables	N/A

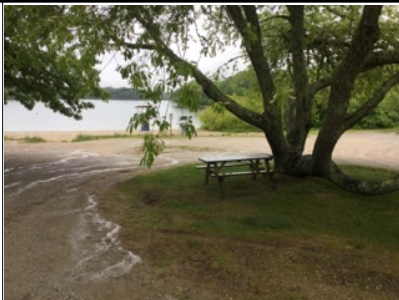
Picnic table not on an accessible route	-	Ensure that the dining surface is connected to an accessible route.  See ID #2 for cost.	1	-	\$0
<b>Toilet &amp; Bathing Rooms</b>

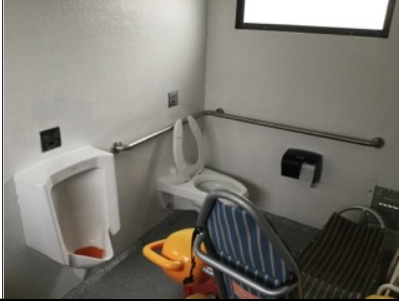
Clearance at toilet < 60" clear width	-	Renovate the toilet room to ensure that there is 60" wide min. clear floor space at the toilet.	1	-	\$0
<b>Dispensers</b>												
10	Men's Toilet Room	1		Dispensers	Other

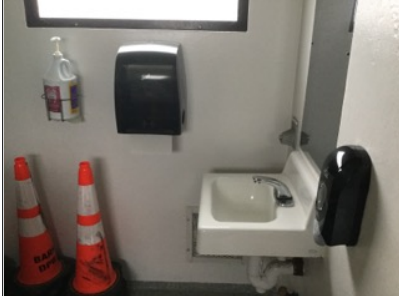
Dispenser acts as a protruding object Audible and visible alarms not provided	6.5"	Relocate dispenser so it does not interfere with the clear floor space at the lavatory. When fire system is updated, ensure that a visible and audible fire alarm is installed.	1	256	\$256
11	Women's Toilet Room	1		Dispensers	Soap Dispenser

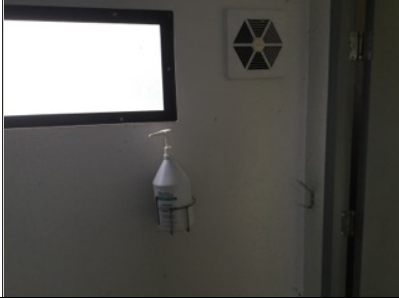
Dispenser acts as a protruding object Audible and visible alarms not provided	6.5"	Relocate dispenser out of the circulation path. When fire system is updated, ensure that a visible and audible fire alarm is installed.	1	Labor	\$0

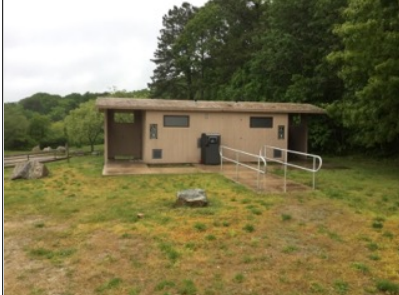
<b>Best Practice</b>												
<b>Bench</b>												
12	Bath House	Ext.		Bench	N/A

Recommend providing a bench at this location and around the pond.	1	-	\$0
