Artist Shanties at Harbor Overlook

Town of Barnstable
ADA Transition Plan

August 2021

**Town of Barnstable
Artist Shanties at Harbor Overlook**

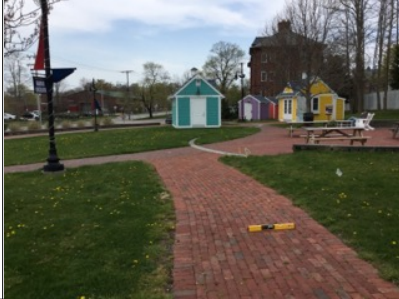
ID	Location	Floor	Room	Element	Type	Photo	Issues	Current Measure	Recommendations	Quantity	Price	Cost Estimation
Approach and Entrance												
Exterior Access Route												
1	Pathway to Artist Shanties From Ocean Street	Ext		Exterior Access Route	Walkway

Cross slope > 1:50 (2.00%)	3%	Reduce cross slope to be no steeper than 1:50 (2.00%).	1	-	\$0
2	Pathway Leading to Ocean Street	Ext		Exterior Access Route	Walkway

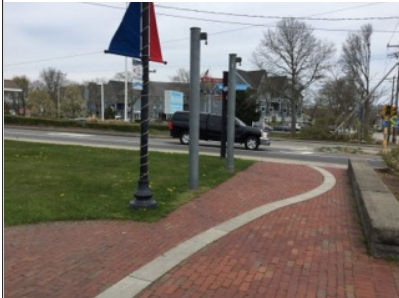
Level changes > 1/4"	1.75"	Alter change in level to be 1/4" high max. at Ocean street sidewalk.	1	-	\$0
3	Pathway Leading to South Street	Ext		Exterior Access Route	Walkway

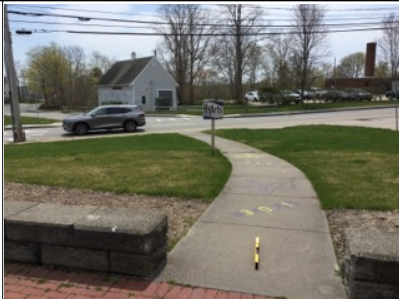
Route not maintained in operable working condition	-	Ensure the accessible route is maintained in operable working condition.	1	-	\$0
4	Pathway Leading to South Street	Ext		Exterior Access Route	Walkway

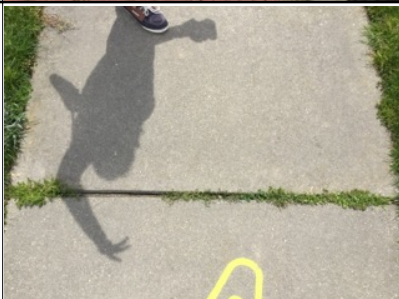
Route not maintained in operable working condition	-	See ID #3.	1	-	\$0
5	Sun Dial - Artist Shanties Pathway	Ext		Exterior Access Route	Walkway

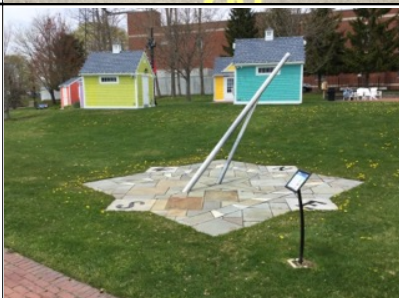
Accessible route not provided	-	Locate wayside near the accessible route.	1	Labor	\$0

- Some areas around the path have excessive change in level.
- Two of the shanties lack an accessible entrance.
- The picnic area lacks an accessible picnic table.
- The wayside near the sundial is not located on an accessible route.

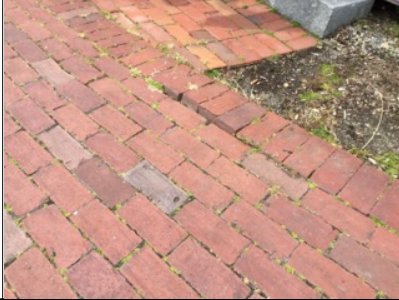
Level changes > 1/4"	1"	Alter change in level to be 1/4" high max. See ID #7.	1	-	\$0
Entrance												
7	Hathaway's Shanty	Ext		Entrance	Main Entrance

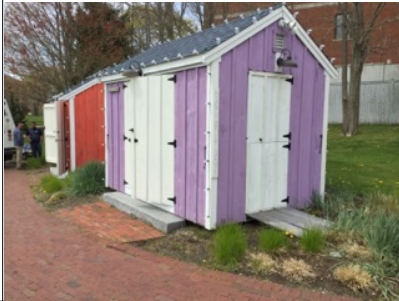
Entrance not on an accessible route	-	Ensure there is an accessible entrance to the shanty.	1	-	\$0
8	Kalmus Shanty	Ext.		Entrance	Main Entrance

Cost to provide an accessible entrance to two of the shanties is not included.

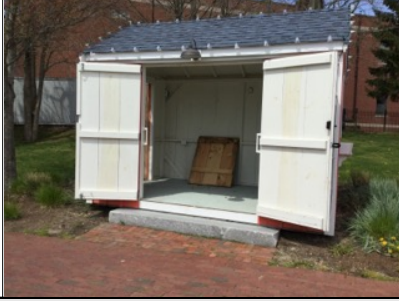
Entrance not on an accessible route	-	Ensure there is an accessible entrance to the shanty.	1	-	\$0
Access to Goods and Services												
Picnic Tables												
9	Seating Area - Near Ocean Street	Ext		Picnic Tables	N/A

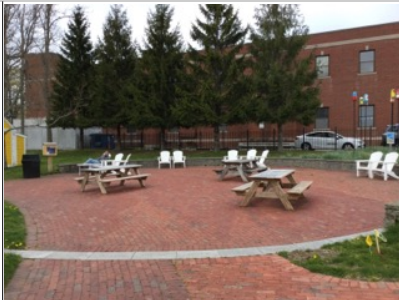
Number of seating spaces at picnic tables Toe or knee clearance at table not provided	3 -	Provide at least one picnic table with top between 28"- 34" above the ground and 27" clear height underneath.	1	1400	\$1400

- Miscellaneous corrective actions (accessible picnic table, etc.): \$1400

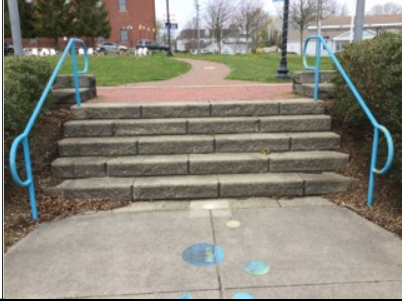
Recommend adding contrasting strips at the edge of each step at the exterior stairs.	1	-	\$0
Benches												
11	Near Kalmus Shanty	Ext		Benches	N/A

- Recommend adding contrasting strips at the edge of each step at the exterior stairs.
- Recommend providing a 36" by 48" clear floor space adjacent to the bench. Ensure shoulder alignment is provided.

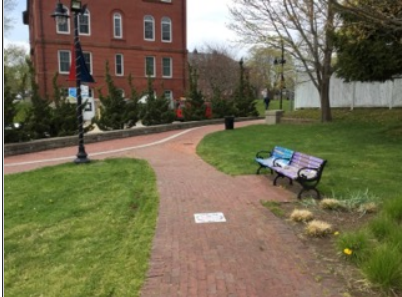
Recommend providing a 36" by 48" clear floor space adjacent to the bench. Ensure shoulder alignment is provided.	1	-	\$0
