# Comfort Station at 329 Millway Road

## Town of Barnstable ADA Transition Plan

July 2021

Institute for Human Centered Design

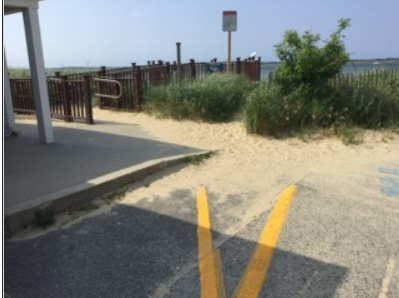
ID	Location	Floor	Room	Element	Type	Photo	Issues	Current Measure	Recommendations	Quantity	Price	Cost Estimation
<b>Approach and Entrance</b>												
<b>Exterior Access Route</b>												
1	Path to Accessible Toilet Room	Ext.		Exterior Access Route	Walkway

Route not maintained in operable working condition	-	Ensure the accessible route is maintained in operable working condition (remove sand).	1	Labor	\$0
2	Bike Rack, East Facade	Ext.		Exterior Access Route	Exterior

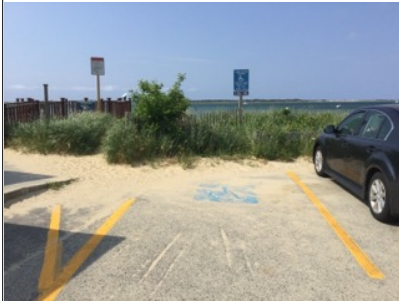
Accessible route not provided	-	Locate bike rack on an accessible route.	1	Labor	\$0
<b>Off-Street Parking Lot or Garage</b>												
3	Parking Lot	1		Off-Street Parking Lot or Garage

Access aisle not provided	-	Provide a marked access aisle that is at least 60" wide.	1	300	\$300
4	Parking Lot	Ext.		Off-Street Parking Lot or Garage	N/A

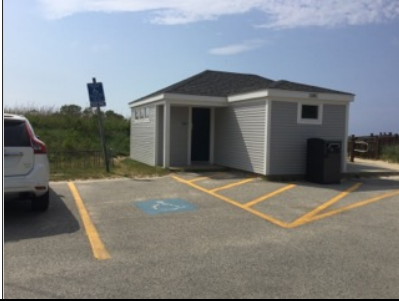
Access aisle < 96" wide at van space Sign does not have the designation "Van Accessible" Sign top > 96" above finished grade	87" - 110"	Provide a marked access aisle that is at least 96" wide. Add the designation "Van Accessible" to the sign located at the van accessible space. Locate sign with the top of the sign 96" above the ground.	1	800	\$800

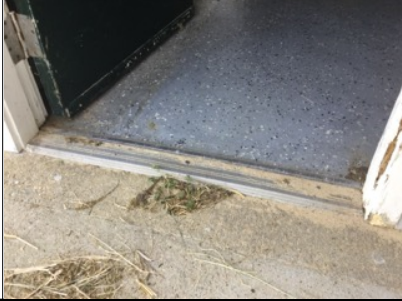
Threshold > 1/2" high	0.75"	Alter the threshold to be 1/2" high maximum.	1	150	\$150
<b>Signage</b>												
6	Accessible Single-User Toilet Room	Ext.		Signage	Designation

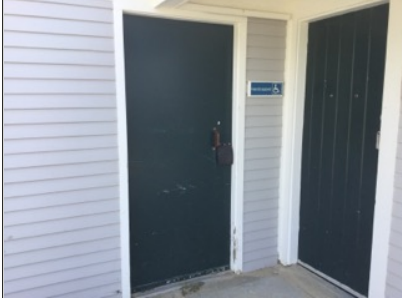
Raised characters not provided on sign Braille not provided on sign	- -	Provide text with raised characters duplicated in braille on sign. Provide braille on sign.	1	232 232	\$232232
7	Men's Multi-User Toilet Room	Ext.		Signage	Designation

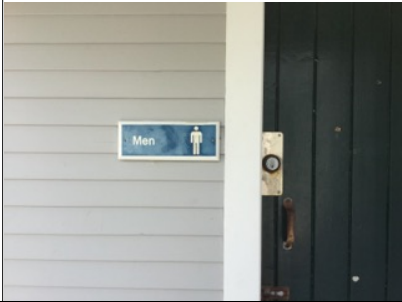
Raised characters not provided on sign Braille not provided on sign Directional sign to access. toilet not provided	- - -	Provide text with raised characters duplicated in braille on sign. Provide braille on sign. Install a sign indicating the location of the nearest accessible toilet room.	2	232	\$464

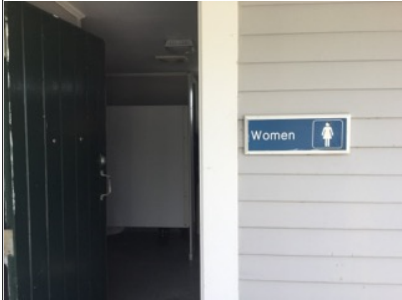
8	Women's Multi-User Toilet Room	1		Signage	Designation

Raised characters not provided on sign Braille not provided on sign Directional sign to access. toilet not provided	- - -	Provide text with raised characters duplicated in braille on sign. Provide braille on sign. Install a sign indicating the location of the nearest accessible toilet room.	2	232	\$464
<b>Toilet &amp; Bathing Rooms</b>

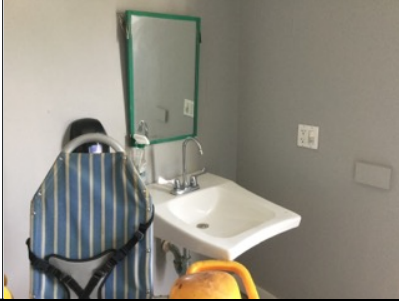
Plumbing underneath is exposed Audible and visible alarms not provided	-	Insulate or otherwise configure pipes to prevent contact for at least one lavatory. When fire system is updated, ensure that a visible and audible fire alarm is installed.  (Cost of fire systems is not provided.)	1	92	\$92
<b>Single-User Toilet</b>												
10	Accessible Single-User Toilet Room	1		Single-User Toilet	N/A

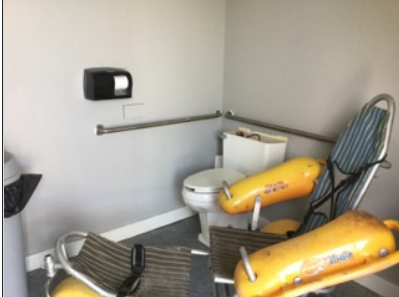
Toilet seat < 17" or > 19" high Flush control not on open side Toilet paper dispenser is not compliant	20" - -	Install a toilet with a seat between 17"- 19" high above the finished floor. Relocate the flush control to the open side. Relocate toilet paper so that it is 24" minimum high, located under the grab bar, and between 7" and 9" from the front of the toilet.	1	2796	\$2796

Accessibility issues at the single user-toilet room include the toilet seat mounted higher than the maximum height allowed, noncompliant toilet paper dispenser, and the flush control is not on the open/transfer side. Additional issues include plumbing underneath the lavatory is exposed, and audible and visible alarms are not provided.
