# Hamblin Pond and Bathhouse

Town of Barnstable  
ADA Transition Plan

August 2021

**Town of Barnstable  
Hamblin Pond and Bathhouse**

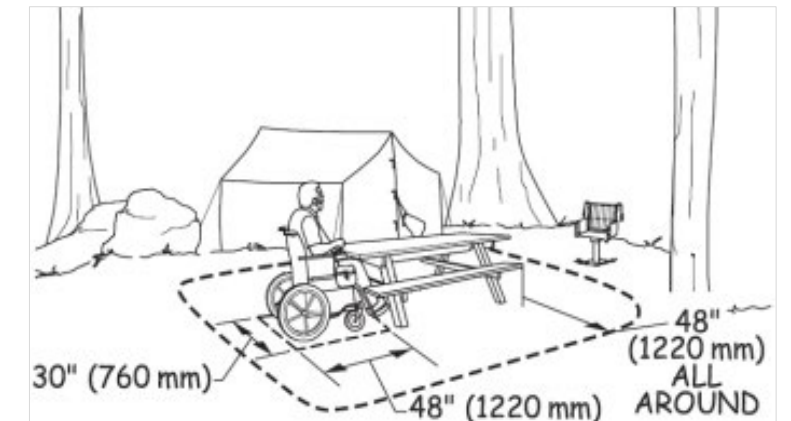
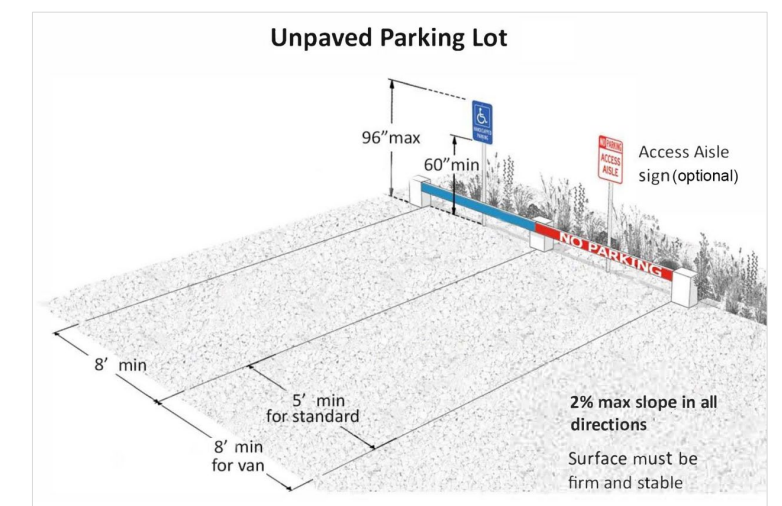
Hamblin Pond and Bathhouse

- Ramp to the bathhouse is not connected to an accessible route.
- Parking lot lacks a van designated parking space (see drawing for possible van accessible parking space design).
- Route around the pond is not firm and stable.
- Accessible route to the recreation water level at the pond is not provided.
- Maneuvering clearance at the toilet is slightly narrower than allowed due to the location of the urinal and dispensers protrude into the circulation path.
- Picnic table is not accessible.
- Designation signs lack raised characters.

- Recommend providing some benches with backs and some with arms on accessible routes near the bathhouse and in shaded areas around the pond.
- Recommend providing at least 48" clear ground space all around the picnic table. Ensure surface is stable and firm.
